PROGRAM SUMMARY:

Through regenerative design strategies. The neglected warehouse at 274 Bragg avenue has been repurposed into an industrial-strength home.

Project Name: 274 BRAGG AVENUE RENOVATION

Project Location: 274 Bragg Avenue Auburn, Alabama 36630

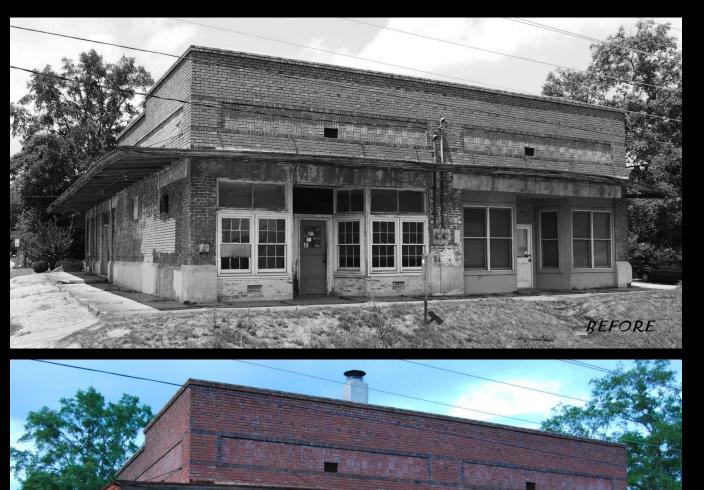
The structure. Originally Built in 1920. PROVIDED Mercantile space along the Intersection of Bragg Avenue and Frazier Street. The historic openings were Recalibrated within the Renovation. But denoted with RAW STEEL PANELS TO PROVIDE A LEGIBLE JUXTAPOSITION BETWEEN THE NEW AND OLD.

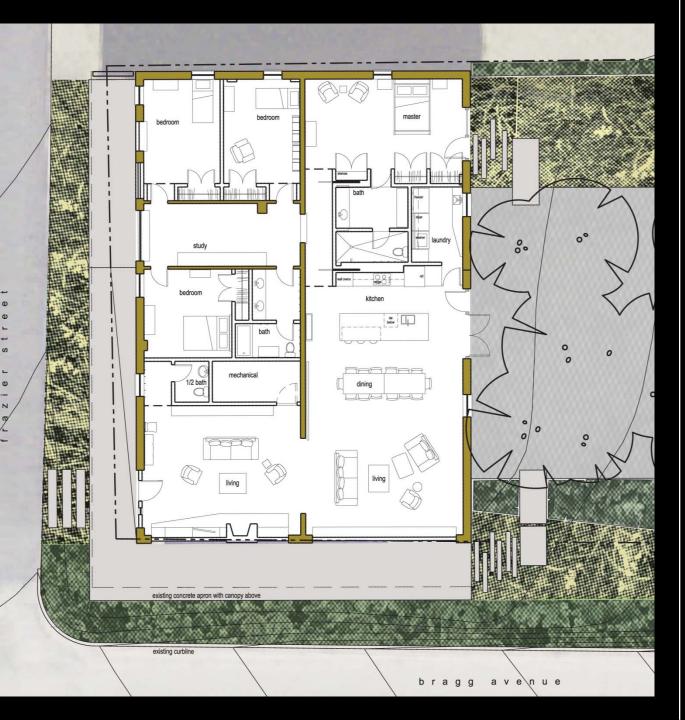
T07.05 274 Bragg Renovation

Strategic openings were introduced within the interior walls to foster new relationships between the four spaces.

CAREFULLY CALIBRATED OPENINGS WERE ALSO INTRODUCED WITHIN THE EASTERN WALL TO INTEGRATE THE INTERIOR WITH THE NEWLY INAUGURATED GARDEN.

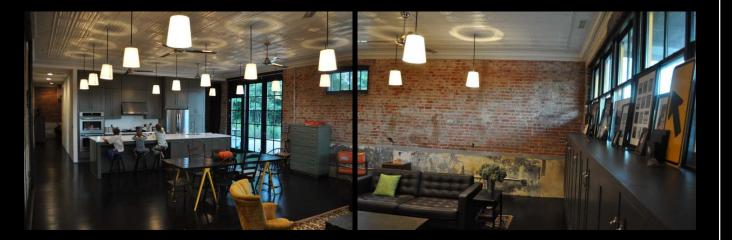
The openings along Bragg Avenue have been thickened and methodically detailed to provide appropriate privacy as well as sound attenuation between the intimate living space and the lively state road.

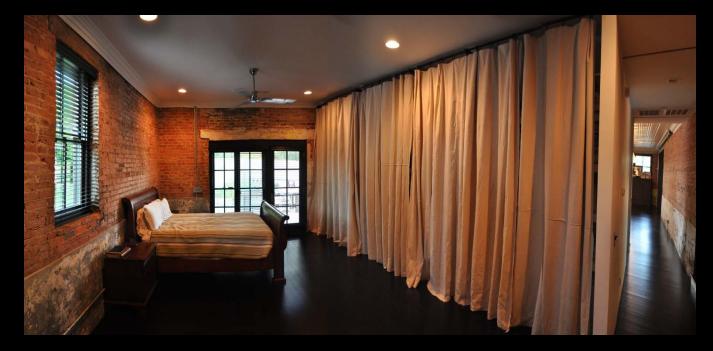
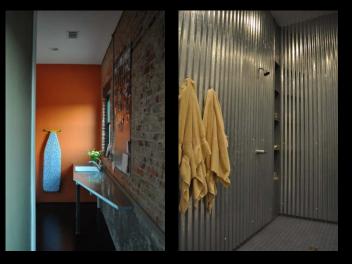
T07.08 274 Bragg Renovation

IN ORDER TO RETAIN THE INDUSTRIAL SCALE VOLUMES OF THE INTERIOR. DENSE PROGRAM OF BATHROOMS, LAUNDRY, CLOSETS, AND STORAGE ARE STRATEGICALLY GATHERED AND EMPLOYED TO SEPARATE BEDROOMS FROM THE PUBLIC SPACES OF THE HOUSE.

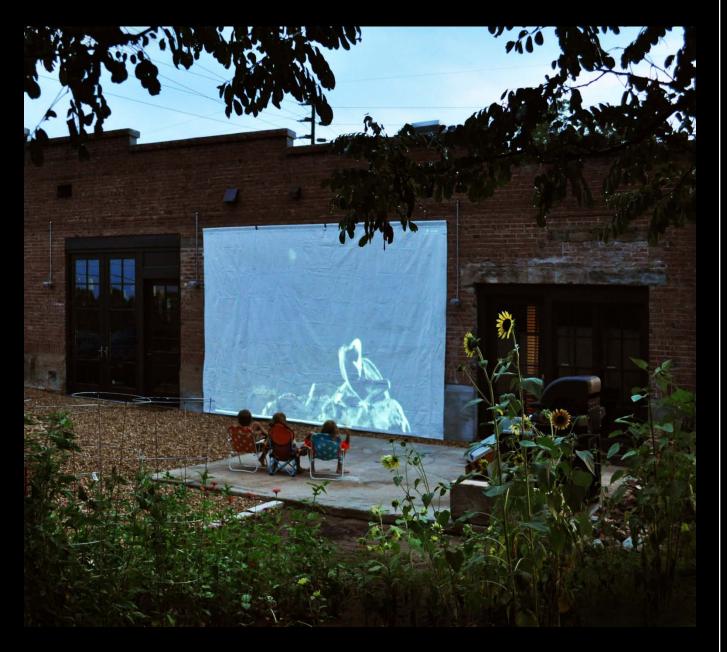
TO7.13 274 Bragg Renovation

In conjunction with other REUSE STRATEGIES WITHIN THE BUILDING. EXTENSIVE PADS OF IMPERMEABLE CONCRETE IN THE LANDSCAPE WERE METHODICALLY DISASSEMBLED AND REUSED. THE RECLAIMED CHUNKS OF CONCRETE WERE ROTATED AND LAID TO REVEAL THE COLORFUL AGGREGATE EXPOSED BY THE CUTTING PROCESS. STORMWATER THAT ONCE FLOWED OVER THE IMPERMEABLE SURFACES AND INTO THE MUNICIPAL SYSTEM NOW PENETRATES THE GROUND. WATERING THE WILD AND WOOLY PLANTS AND RECHARGING THE GROUNDWATER.
